# PUBLIC MEETING No. 2

## Tesla Road Safety Study

## TESLA ROAD SAFETY STUDY

Public Works Agency  
Alameda County

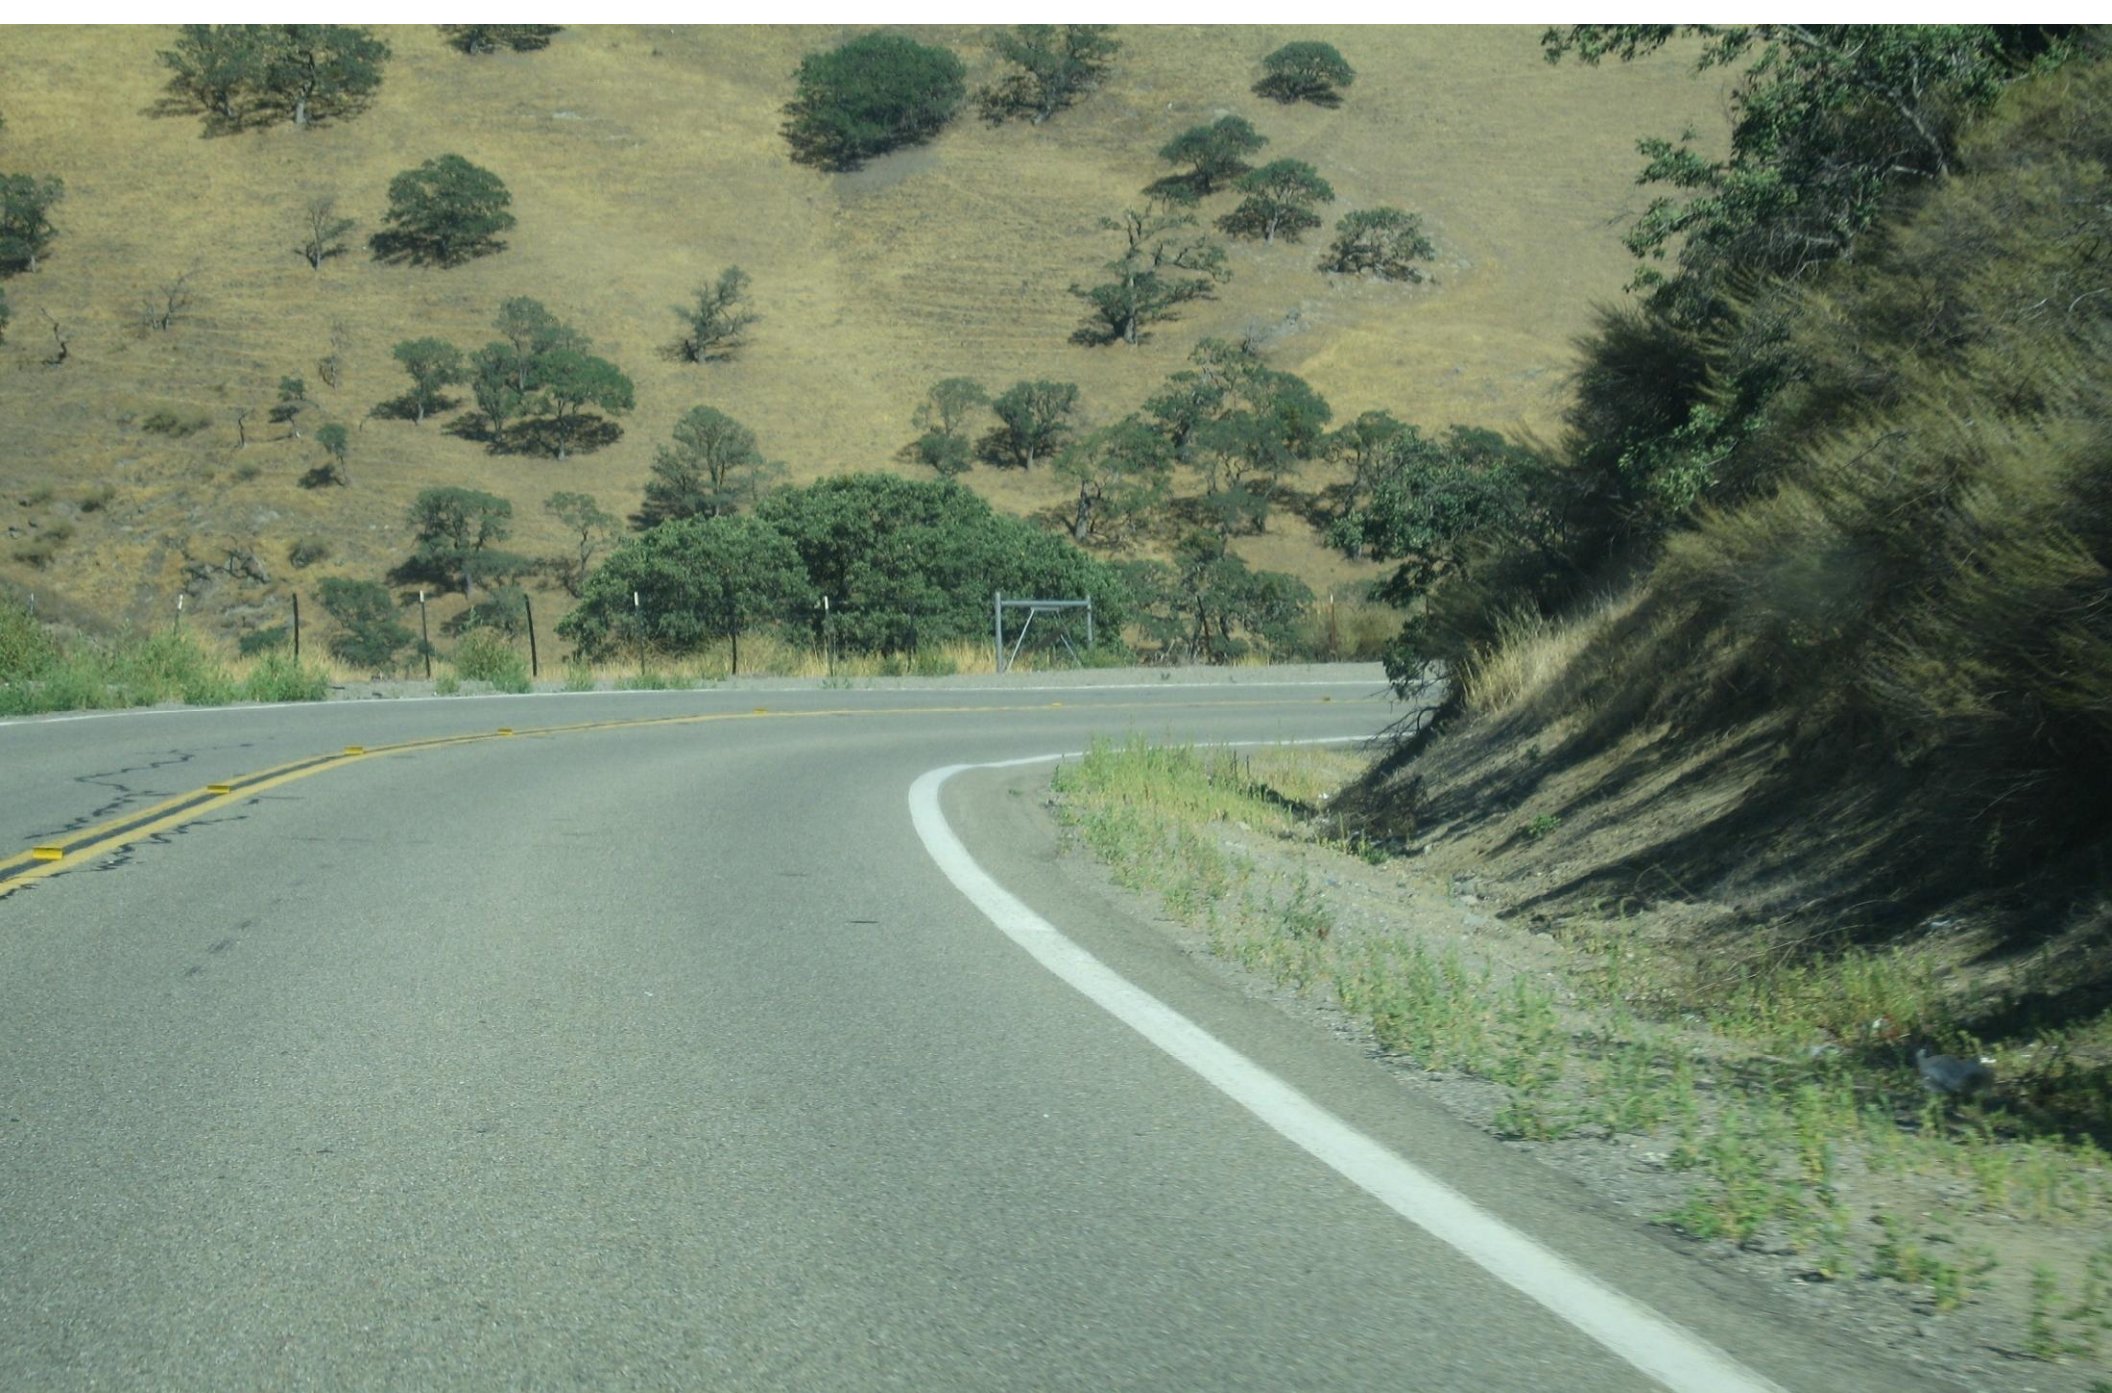
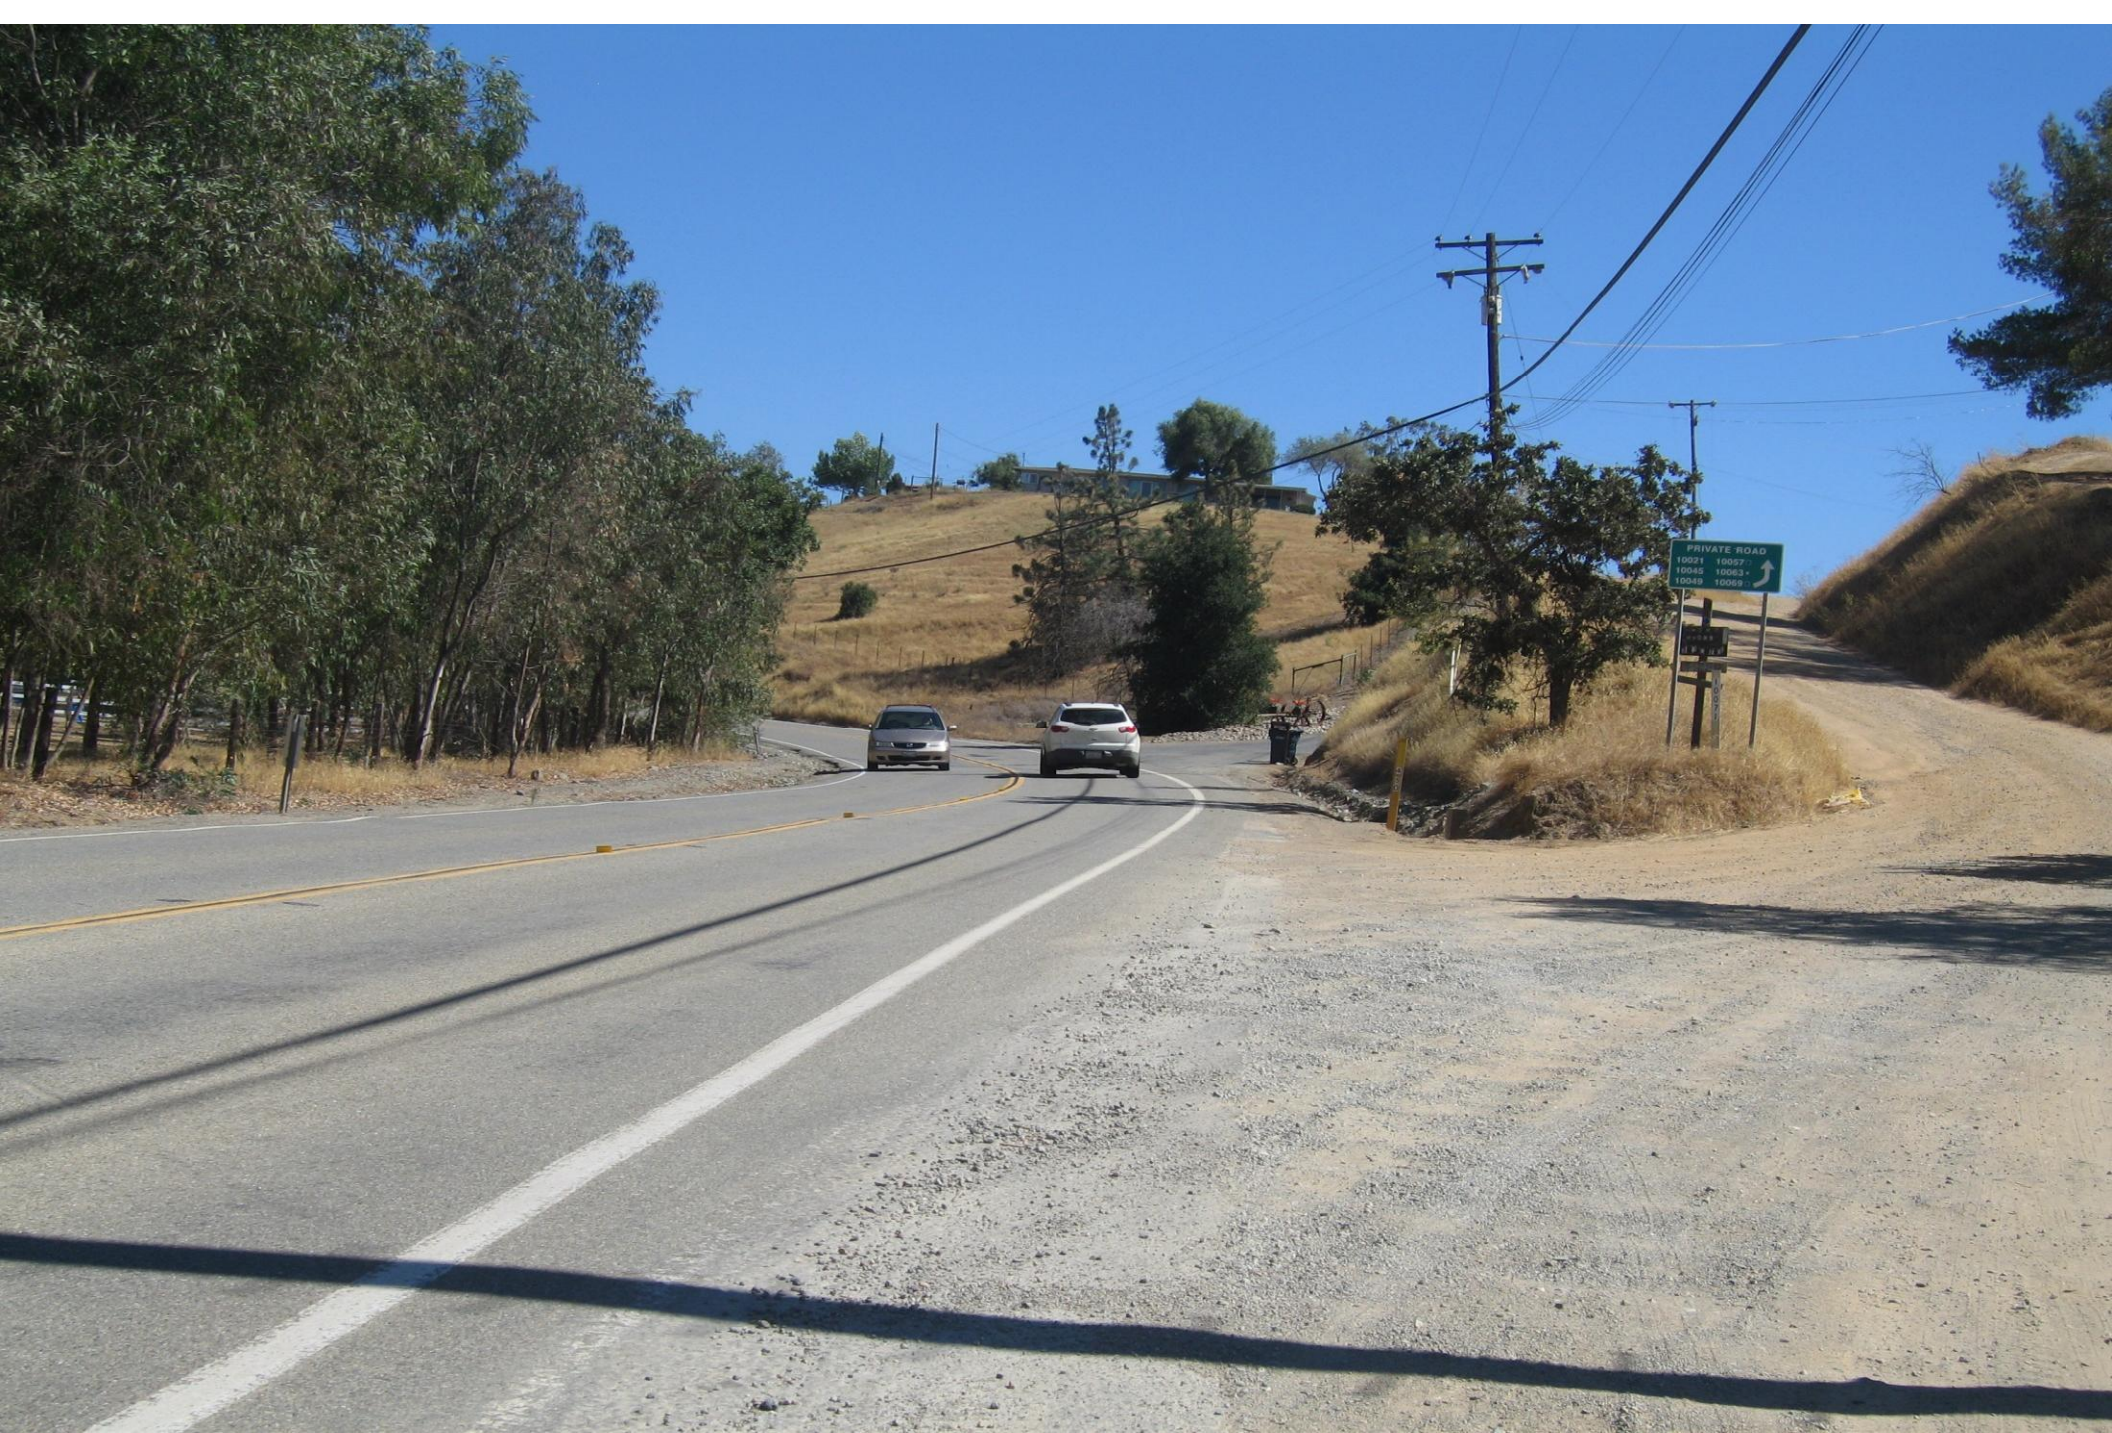
# Tesla Road Vehicle Spot Speeds

## Nov 2012 48 hour Speed Summary

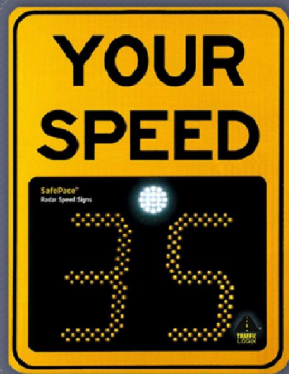
Additional Signs

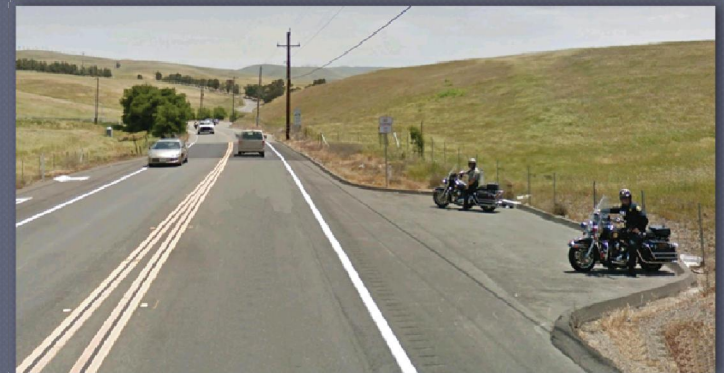
Safety/Enforcement Pull-Out Area

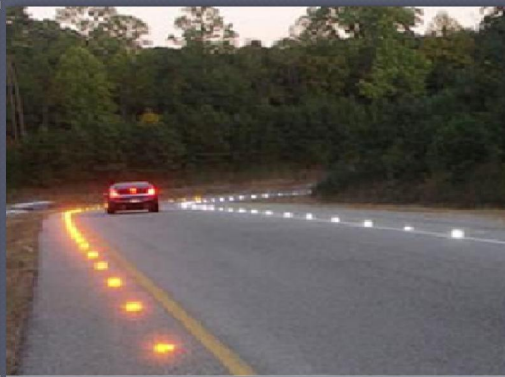
Reflective Pavement Markers

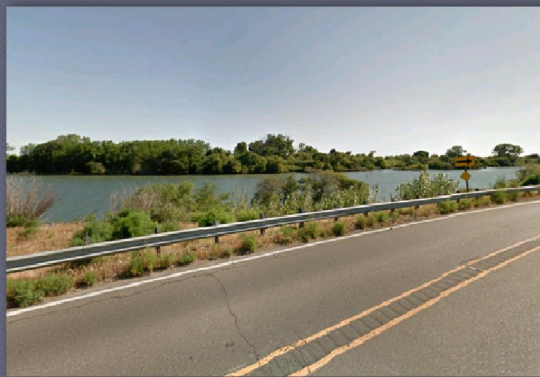
Center Line Rumble Strip

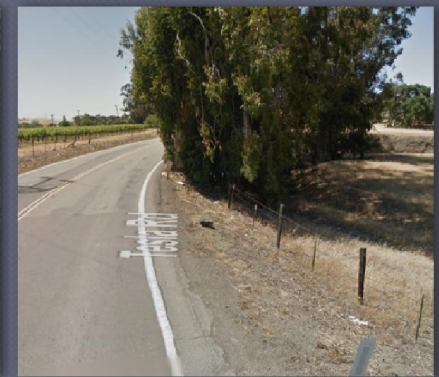
Trim Trees

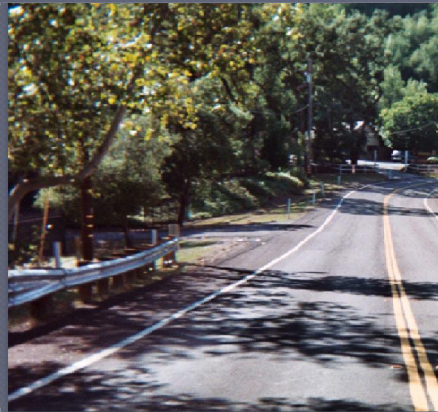
4 ft Wide Paved Shoulder

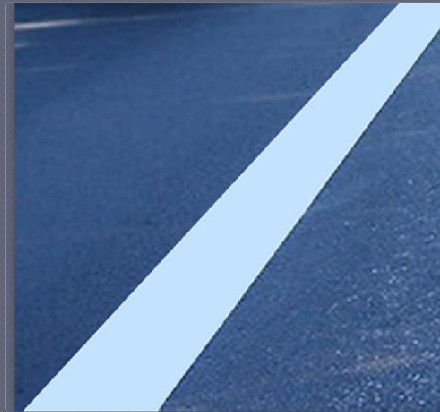
8" Wide White Edge Lines

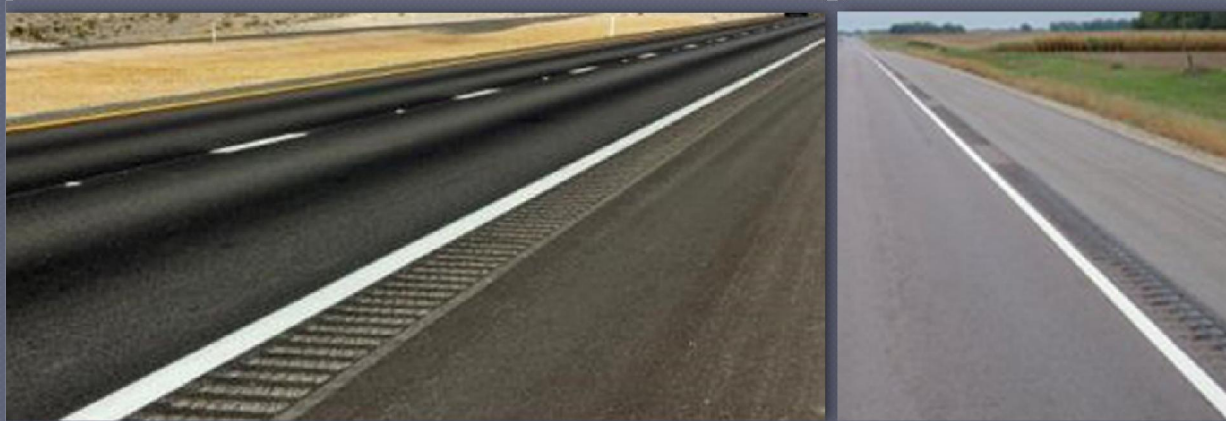
Shoulder Rumble Strips

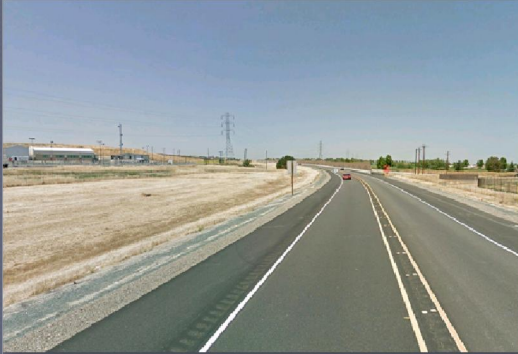
**8 Foot Wide Paved Shoulders**

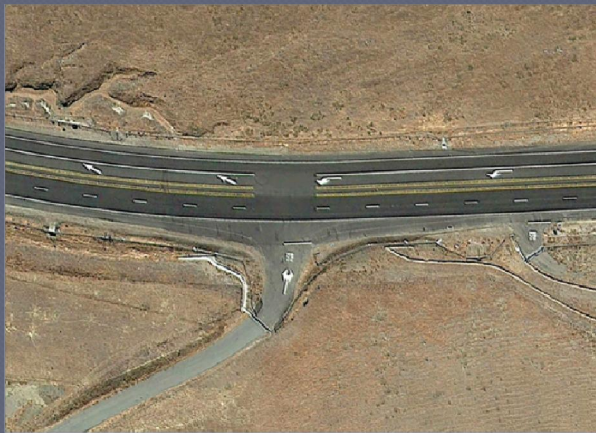
**Left Turn Pockets at Public and Private Street Intersections**

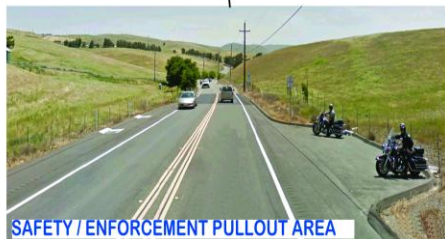
| ISSUE | UNSAFE PASSING AND VEHICLES RUNNING OFF ROAD ALONG S-CURVE. |
| COUNTER-MEASURES | NEAR-TERM: SPEED FEEDBACK SIGNS, ADD'L WARNING SIGNS, TRIM TREES, CENTERLINE RUMBLE STRIPS, REFLECTIVE PAVEMENT MARKERS, 8" WIDE EDGE LINE, SAFETY/ENFORCEMENT PULLOUT AREA.<br>MID-TERM: SHOULDER RUMBLE STRIPS, 4' WIDE SHOULDERS |

| ISSUE | UNSAFE PASSING, VEHICLES RUNNING OFF ROAD |
| COUNTER-MEASURES | NEAR-TERM: ADVANCE CURVE WARNING SIGNS, DO NOT PASS SIGNS, CENTERLINE RUMBLE STRIPS, 8" WIDE EDGE LINE, REFLECTIVE PAVEMENT MARKERS, SAFETY/ENFORCEMENT PULLOUT AREA<br>MID-TERM: SHOULDER RUMBLE STRIPS, 4' WIDE SHOULDERS |

| ISSUE | VEHICLES RUNNING OFF ROAD, DRIVEWAY ACCESS |
| COUNTER-MEASURES | NEAR-TERM: ADVANCE CURVE WARNING SIGNS, 8" WIDE EDGE LINE, REFLECTIVE PAVEMENT MARKERS, IMPROVE DRIVEWAYS, SAFETY/ENFORCEMENT PULLOUT AREA<br>MID-TERM: SHOULDER RUMBLE STRIPS, 4' WIDE SHOULDERS |

| ISSUE | VEHICLES RUNNING OFF ROAD AND OVERTURNING AT SHARP CURVES, UNSAFE PASSING |
| COUNTER-MEASURES | NEAR TERM: ADVANCE CURVE WARNING SIGNS, SPEED FEED BACK SIGNS, CHEVRON SIGNS, REFLECTIVE PAVEMENT MARKERS, 8" WIDE EDGE LINE, TRANSVERSE RUMBLE STRIPS, CENTERLINE RUMBLE STRIPS, INSTALL/REPLACE GUARD RAIL<br>MID-TERM: SHOULDER RUMBLE STRIPS, 4' WIDE SHOULDERS |
